National Transportation Safety Board

Aircraft Accident Investigative Update

On January 26, 2020, at 0945 Pacific standard time (PST), a Sikorsky SK76B helicopter, N72EX, collided with hilly terrain near the city of Calabasas, California. The pilot and eight passengers were fatally injured, and the helicopter was destroyed by impact forces and fire. The helicopter was operated by Island Express Helicopters Inc. under Title 14 Code of Federal Regulations (CFR) Part 135 as an on-demand passenger visual flight rules (VFR) flight from John Wayne-Orange County Airport, (KSNA), Santa Ana, California, to Camarillo Airport, (KCMA), Camarillo, California.

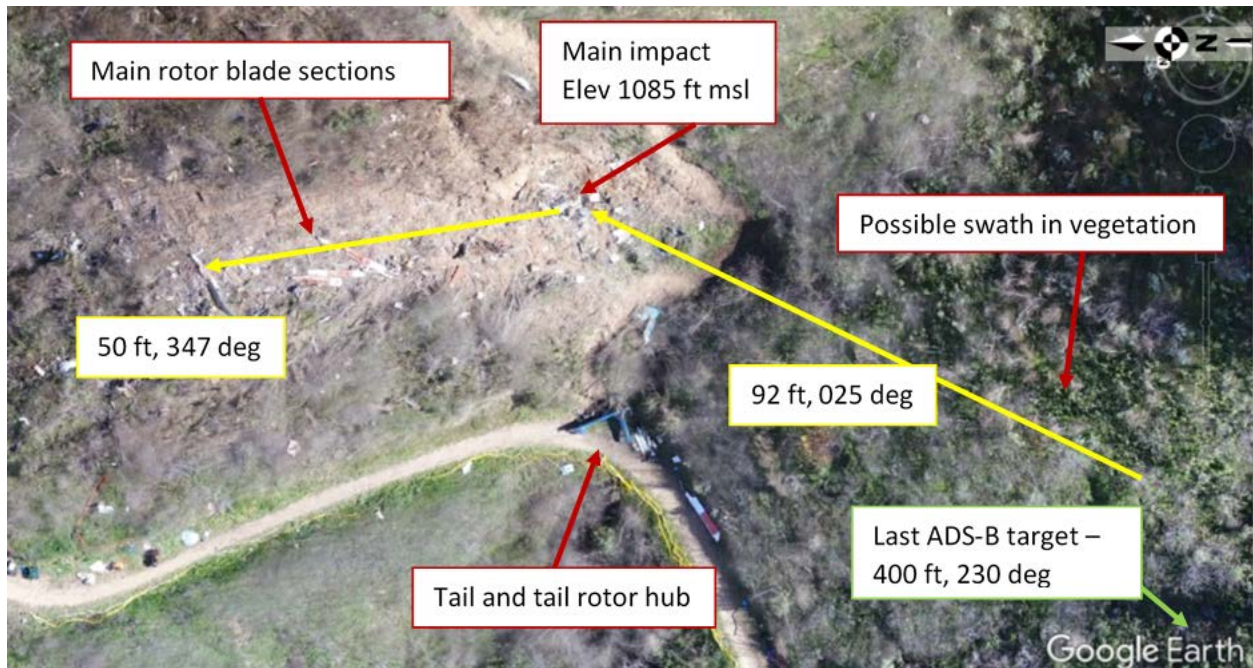
The wreckage was located in the foothills of the Santa Monica mountains, in a mountain bike park. The impact site was on an approximate 34° slope. The impact crater was 24 feet-by-15 feet in diameter and 2 feet deep.

Figure 1a. Google Earth map of wreckage area – southern (directions reference true north)

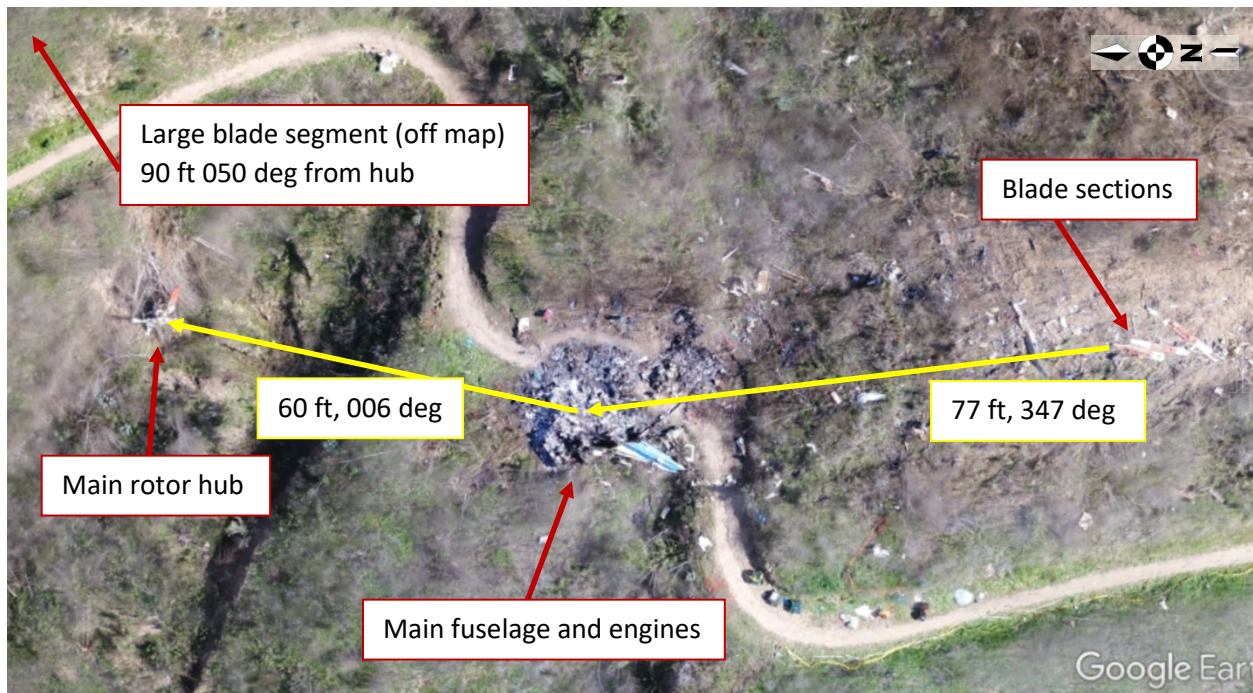
Figure 1b. Google Earth map of wreckage area – northern

All significant components of the helicopter were located within the wreckage area. Examination of the main and tail rotor assemblies found damage consistent with powered rotation at the time of impact. The initial point of impact consisted of highly fragmented cabin and cockpit debris. The vertical pylon and horizontal stabilizer were located about 40 feet below (downhill from) the

impact crater. A witness mark consistent with the length and width of a rotor blade and containing fragments of rotor blade skin and honeycomb was positioned perpendicular to the direction of the debris line and directly above the impact crater. One piece of 2-inch diameter tree branch was cut cleanly in 3 locations (similar to saw cuts) about 30 feet prior to the initial impact crater. Approximately 95% of the main rotor blades were recovered. All four blades exhibited similar damage consisting of midspan bending, pocket separation, blade tip separation, and leading-edge indentations and scuffing.

The main wreckage was about 127 feet from the impact crater along a 347° true bearing (335° magnetic) and consisted of the empennage/tailboom, both engines, avionics boxes, and portions of the cockpit instrument panel. The entire fuselage/cabin and both engines were subjected to a postcrash fire. The cockpit was highly fragmented. The instrument panel was destroyed and most instruments were displaced from their panel mounts. Flight controls were fragmented and fire damaged.

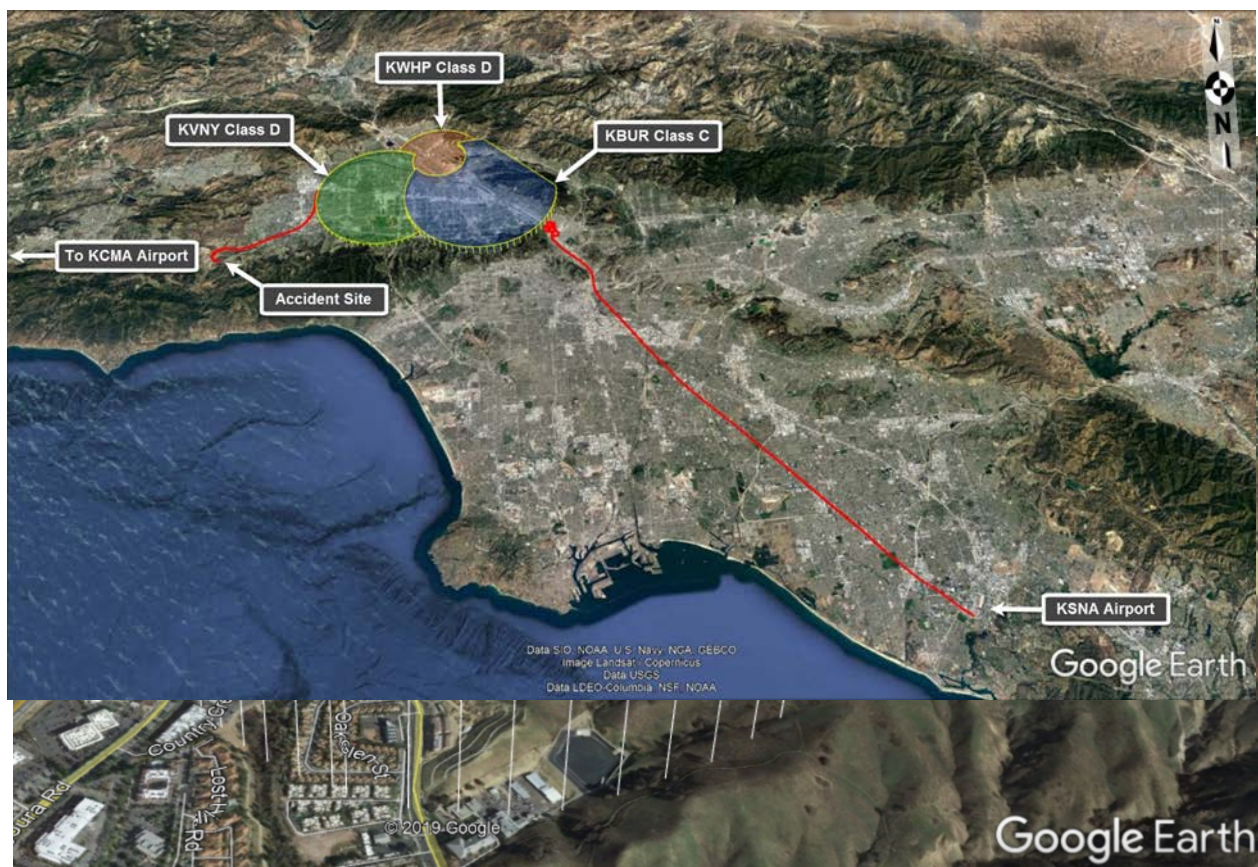
Radar/ADS-B data indicate the aircraft was climbing along a course aligned with Highway 101 just east of the Las Virgenes exit. Between Las Virgenes and Lost Hills Road, the aircraft reached 2,300 feet msl (approximately 1,500 feet above the highway, which lies below the surrounding terrain) and began a left turn. Eight seconds later, the aircraft began descending and the left turn continued. The descent rate increased to over 4,000 feet per minute (fpm), ground speed reached 160 knots. The last ADS-B target was received at 1,200 feet msl approximately 400 feet southwest of the accident site.

Figure 2. Overall Radar/ADS-B track of N72EX

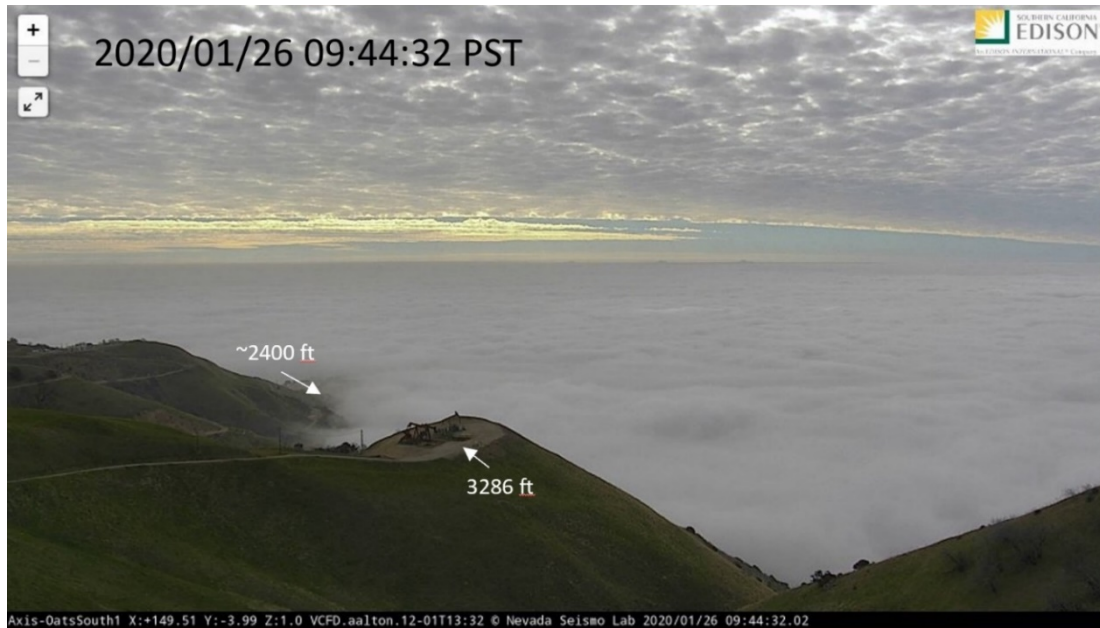
An ALERTWildfire camera image (figure 4) taken at 0944 PST looking southeast toward the city of Van Nuys, as publicized on the National Weather Service (NWS) Los Angeles Twitter account, depicted the top of the cloud layer to the east of the accident site. The NWS analyzed the top of the cloud layer to be about 2,400 feet above mean sea level near the terrain in the foreground of the image.

Figure 4. Camera image from 0944 PST

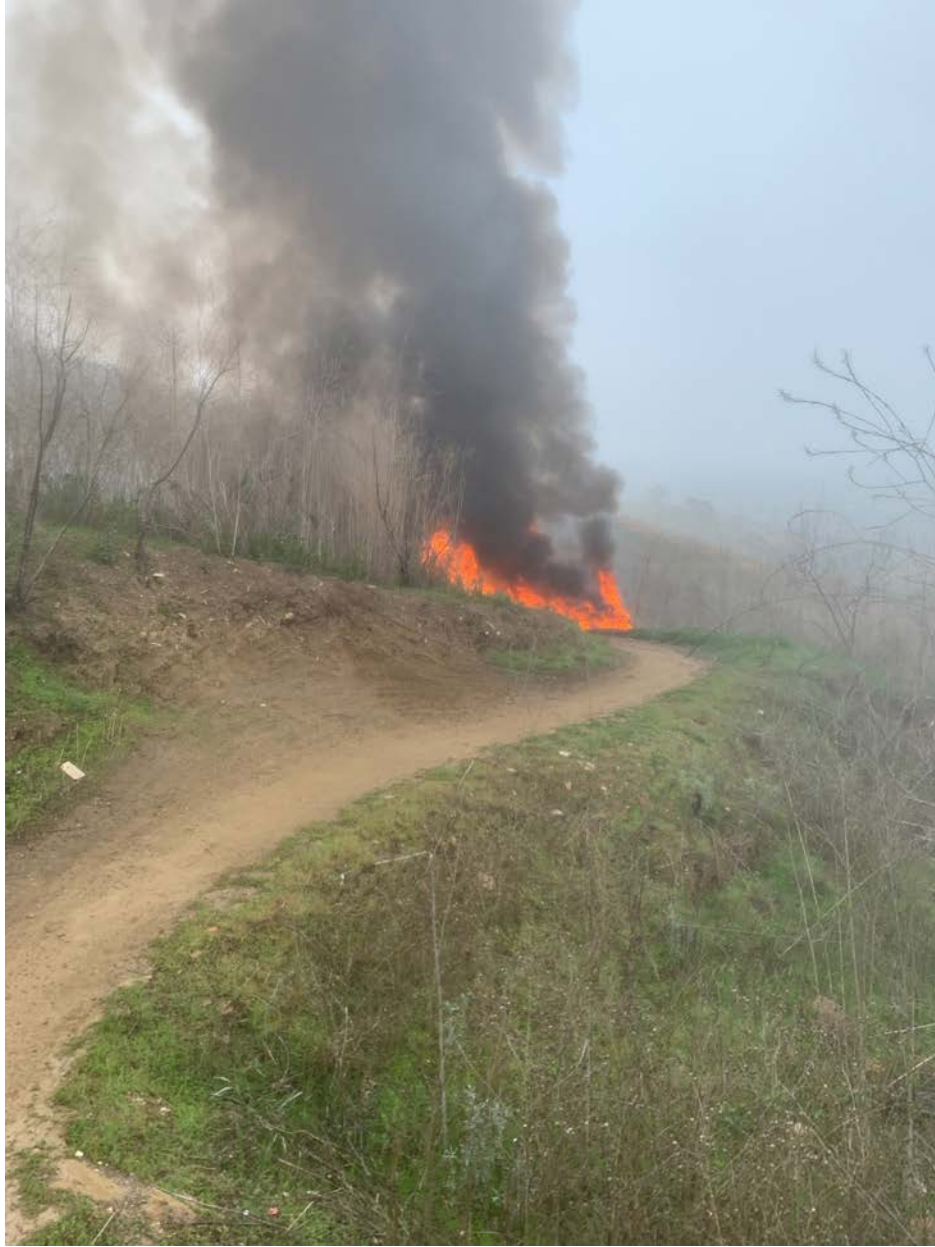
Videos and photos taken by the public in the area of the accident also depict fog and low clouds obscuring the hilltops. Figure 5a was taken by a witness on the mountain bike trail about 0950. The witness stated that the area was surrounded by mist. He said he began to hear the sound of a helicopter, which he described as appropriate for a helicopter flying while in a powered condition. He perceived the sound getting louder and saw a blue and white helicopter emerge from the clouds passing from left to right directly to his left. He judged it to be moving fast, travelling on a forward and descending trajectory. It started to roll to the left such that he caught a glimpse of its belly. He observed it for 1 to 2 seconds, before it impacted terrain about 50 feet below his position.

Figure 5a. Witness photo of accident site and weather conditions.

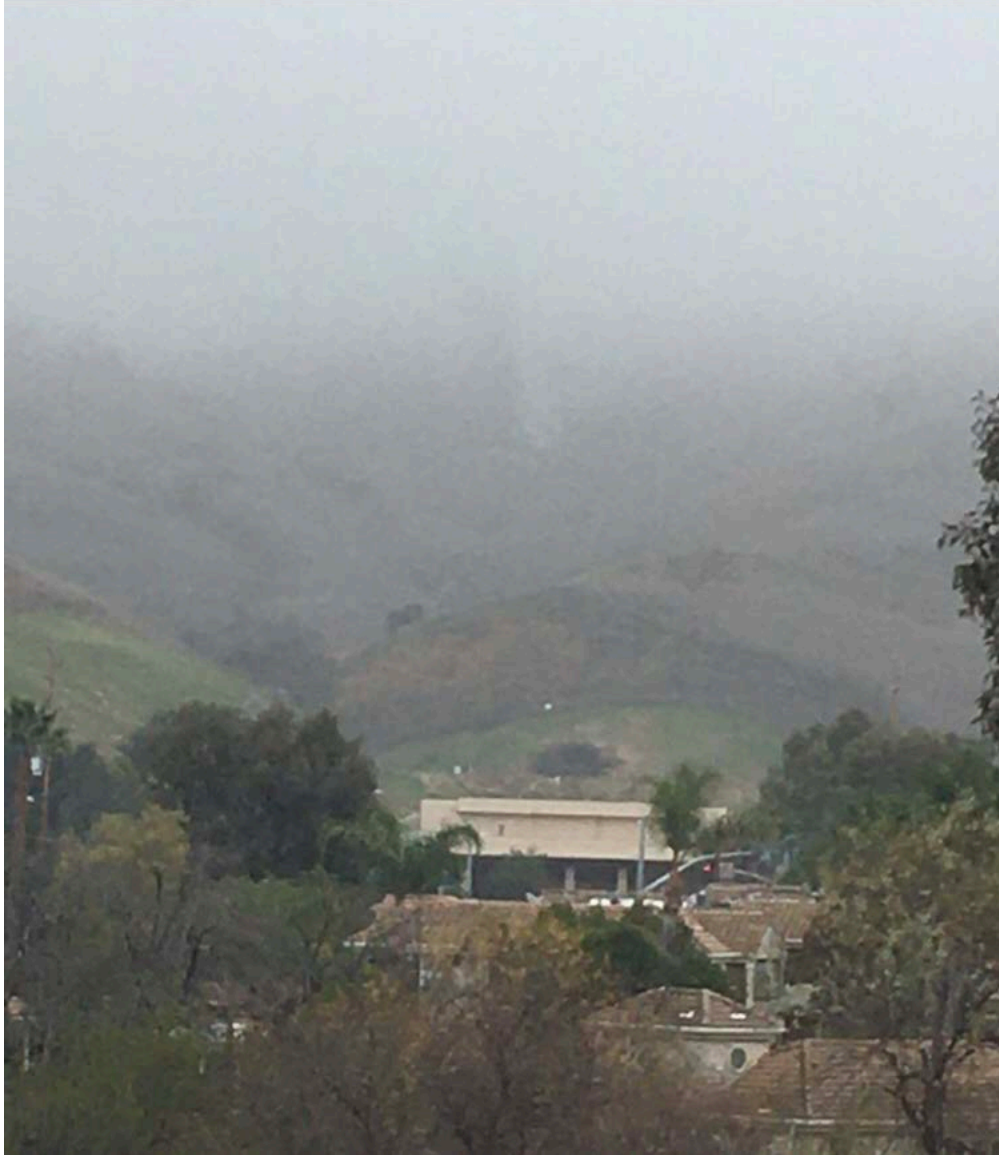
Figure 5b was taken by a nearby resident about 5 minutes after the accident from a location about 4,000 feet west of the site at an elevation of 750 feet msl.

Figure 5b. Resident photograph.

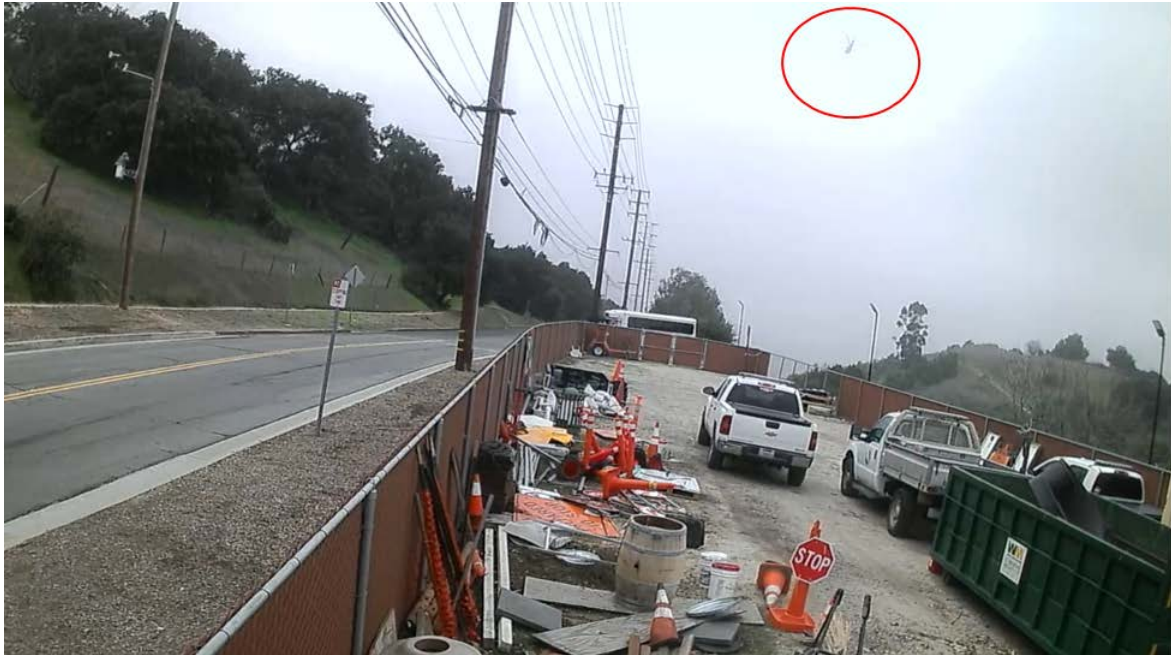
Figure 6 is a still frame from a security video obtained from a road maintenance yard adjacent to Moreau Road and Highway 101 depicting the helicopter proceeding westward along the highway and disappearing into the clouds.

Figure 6. Still frame from security video showing N72EX flying into clouds (circled in red)
